# The Case of Stray Voltage in a Lake

Faulty concentric neutrals on high-voltage underground cables lead to one teenage swimmer's drowning and two others' brain injuries.

Donald R. Johnson, P.E., Johnson Engineering | Nov 01, 2009

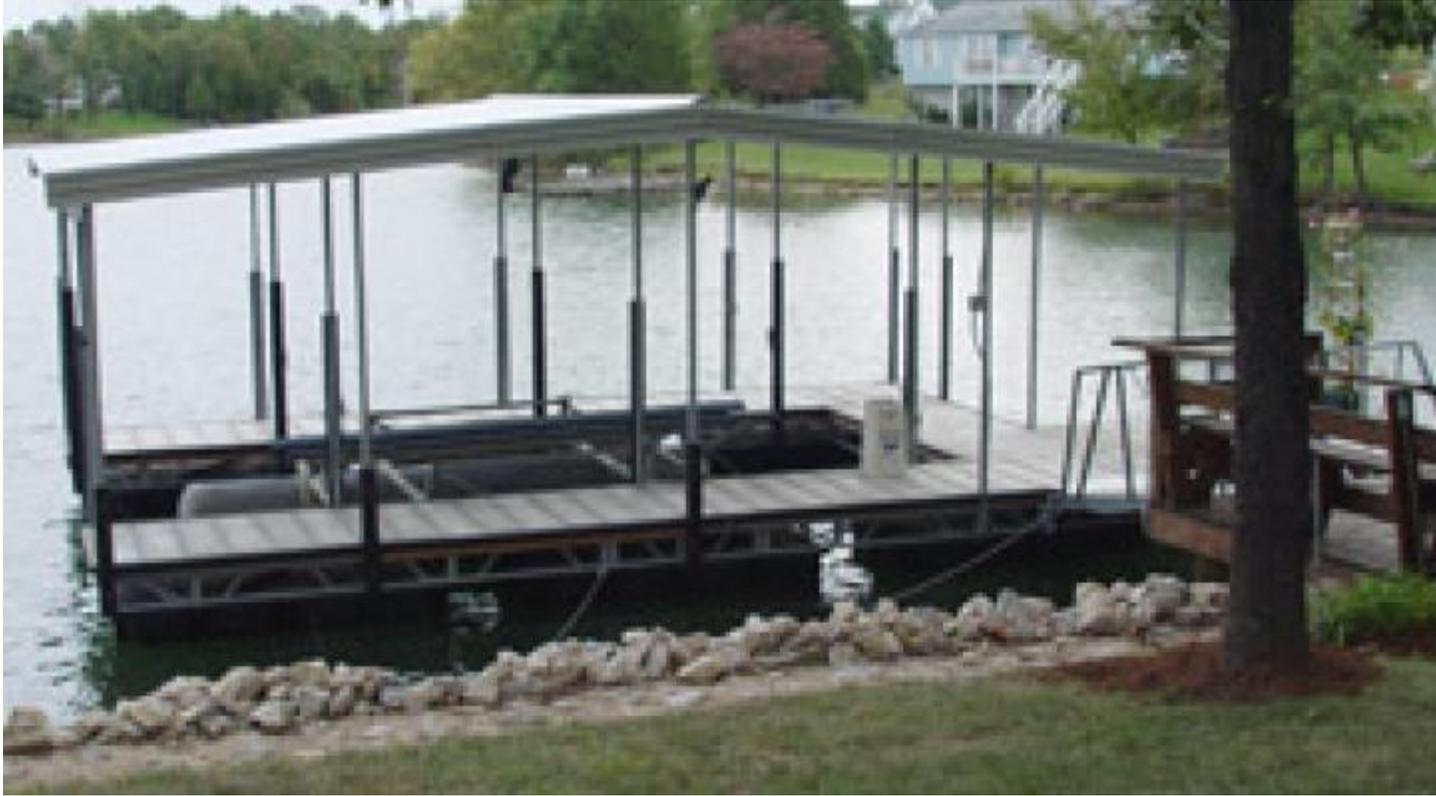
After numerous investigations by myself and other experts, we concluded that the dock wiring was not the cause of the electric currents in the lake water (**Photo 1**). However, I later discovered that the electric utility had major corrosion problems with the bare concentric neutrals of its high-voltage underground cables, which were buried under and around the lake where the accident occurred. To get a better idea of what a cable with a good and bad concentric neutral looks like, see **Photo 2**. Although these shots come from another case — one in which the corroded neutrals caused a dairy farmer to lose many cows to disease/death as well as suffer significant loss of milk production in the remaining cows — they clearly demonstrate the difference between normal and deteriorated products.

Up to nine years prior to the accident, the electric utility realized through concentric neutral testing procedures that the bare concentric neutrals were in a serious state of deterioration throughout the lake area and housing subdivision around the lake. Despite this discovery, the electric utility did not take immediate steps to fix the problem. Instead, it began a multi-year program of replacing the bare concentric neutral cables with new jacketed concentric neutral cables in the area. However, due to difficulty in installing new cable in two particular sections of underground cable under and around the lake, these sections were not replaced.

It turned out that these two particular sections of cable were the primary paths for the neutral current return for the entire lake area subdivision back to the electric utility substation source. This meant that the electrical load within the subdivision was essentially on an “island” in terms of an adequate return current path. Because of this island effect, the currents took the least-resistant path into the lake water heading to the dock — a structure that was more than adequately grounded to the electric utility system overhead neutral, which was then tied directly to the utility substation source.
